Inspector General

Better Contract Oversight Could Have Prevented
Deficiencies in the Detention Facility in
Parwan, Afghanistan

SUBJECT: Better Contract Oversight Could Have Prevented Deficiencies in the Detention Facility in Parwan, Afghanistan (Report No. DODIG-2012-089)

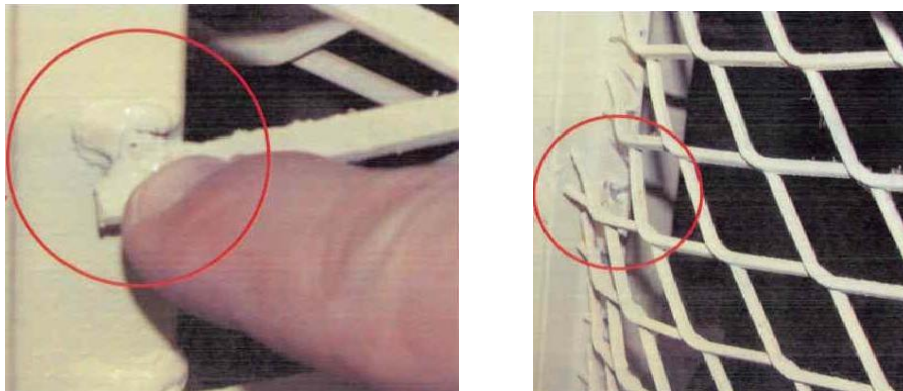
Figure 1. Examples of Poorly Welded Cell Grates

In a Construction Quality Presentation in July 2010, Task Force Rocky Mountain officials stated that the construction quality was not up to the standard suitable for a detention facility, and that the quality of construction of greatest interest was the areas where the detainees spent most of their time such as detention cells and the recreation yard. The presentation went on to say that the poorly constructed cell doors allowed detainees to damage the doors easily by repeated kicking. Figure 1 shows examples of the poor welding and Figure 2 shows the damage to the cell doors caused by the detainees because of the poor construction.

The poorly constructed cell doors allowed detainees to damage the doors easily by repeated kicking.

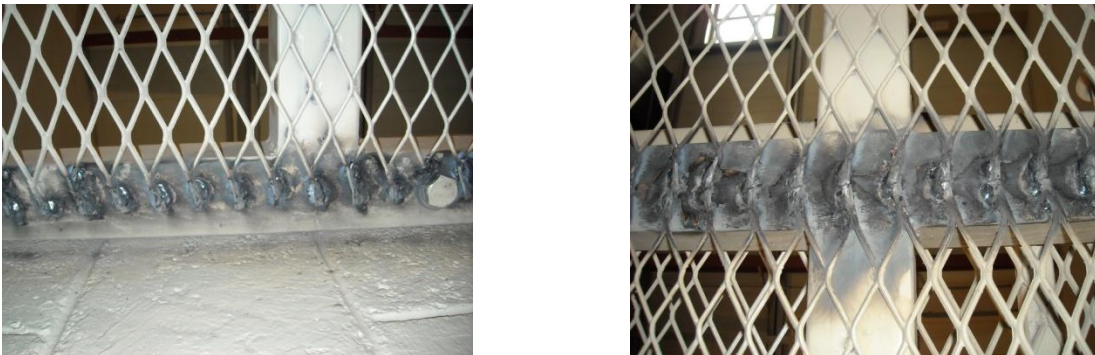
Figure 3. Re-Welded Cell Doors

According to the Task Force Rocky Mountain presentation, the quality of welding required the facility engineers to do extensive rework. Figure 3 shows the rework that DoD OIG engineers inspected in July 2010.

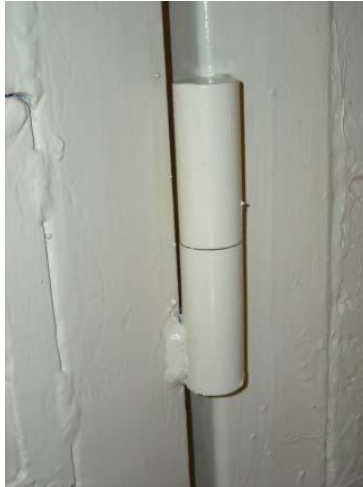
Figure 4. DFIP Hinge

The DFIP cell door hinges were not adequate to hold the weight of the cell doors and required re-welding and replacement. The technical specifications required that each door have full-mortise, heavy-duty hinges that complied with ANSI/BHMA A156.1. To fulfill that standard, the door should have had 1 ½ pairs butt hinges with rectangular leaves welded to both the door and the transom bar. According to the American National

Standard Institute,³ a butt hinge is defined as a hinge with rectangular leaves, usually of the same size, and multiple bearing contacts. Figure 4 shows original hinges installed by the DFIP contractor.

The hinges used did not meet the American National Standard Institute definition of a butt hinge because they did not have rectangular leaves or multiple bearing contacts. The original hinges also do not meet the definition of a 1 ½ pair's butt hinge as required by the statement of work, as the hinges do not have multiple bearings. As a result, some of the doors had broken hinges and other door hinges showed signs of stress from carrying the full load of the door. DFIP authorities were aware of the situation from the time the facility was accepted. USACE TAN engineers stated that the contractor acknowledged the problem and indicated that it was a systemic issue and would replace the doors before the end of the warranty period. However, the doors continued to remain an issue 9 months after acceptance when DoD OIG engineers conducted their inspection in July 2010.

Some of the doors had broken hinges and other door hinges showed signs of stress from carrying the full load of the door.

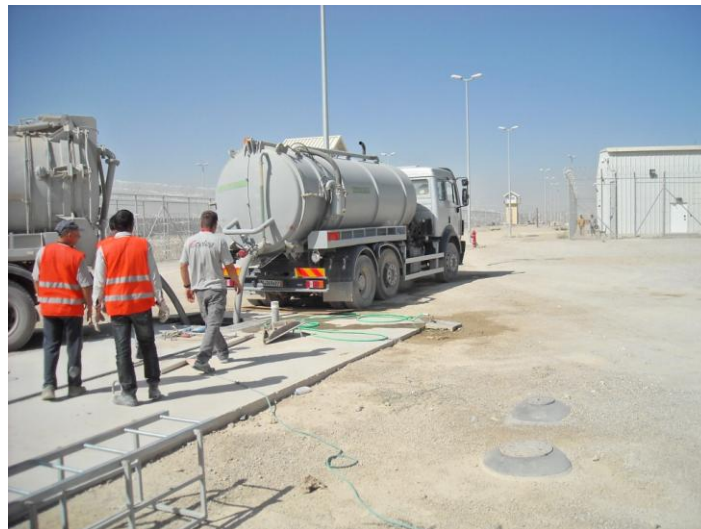
Figure 6. Trucks Collect Sewage

The DFIP sewage system required multiple repairs because the detainees flushed non-organic material down the toilets, which caused the lift station sewage pumps to fail. The contract stated that the sewage system should be constructed in accordance with Unified Facilities Guide Specifications Section 33 32 16.13. Those specifications required submersible sewage pumps that could grind all materials found in normal domestic sewage, including plastics, rubber, sanitary napkins, disposable diapers, and wooden articles. The specifications did not require sewage pumps that could grind materials found in normal “detention” facility sewage.

The contractor built the sewage system with two lift stations designed to allow sewage to pass from the detention facility to the two lift stations located in the DFIP secure courtyard. The two lift stations located in the courtyard would then pump the sewage uphill through transfer lines to a collection point located outside the detention facility. Once at the collection point, sewage trucks collect the sewage for disposal, as shown Figure 6.

According to DoD OIG engineers, who inspected the sewage system in July 2010, the two lift station pumps located in the DFIP courtyard were not built with grinders and were not operational. The lack of grinders caused the sewage to solidify because of the non-organic materials, such as uniforms, being flushed down the toilets by the detainees. Once the sewage hardened inside the lift station, the waste level began to rise above the sewage lines

In April 2010, Joint Task Force 435 personnel justified purchasing the sewage material grinders by stating that the two lift station pumps were replaced at a considerable cost, and the system was being pumped out from the lift station holding tanks. The justification also stated that the continued operation without the grinders could result in the having to remove, rebuild, or replace the pumps at an even greater cost.

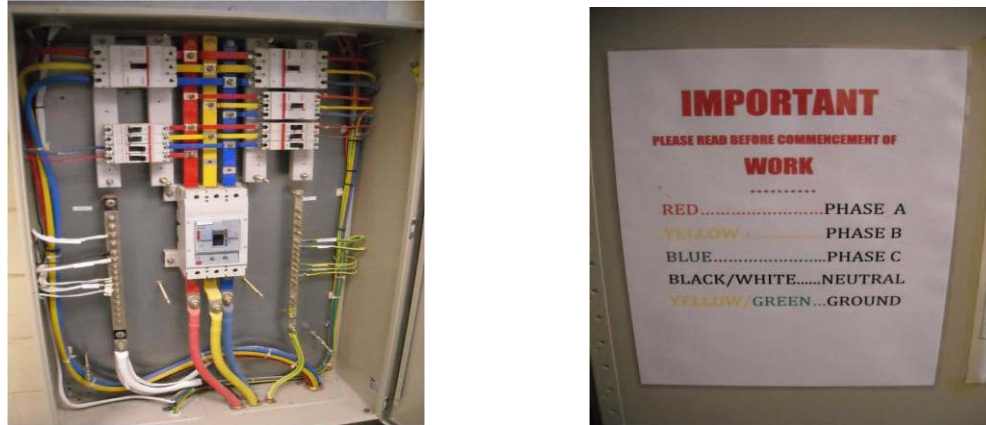
Figure 7. The Electrical System Panel (left) and Explanation of the System (right)

Personnel who had experience with the British Standard installed the British Standard electrical system during construction, and posted the explanation of the British Standard inside the electrical panels (see figure 7 [right]).

Contractors, once U.S. personnel started operating the facility, made changes to the British Standard wiring convention so that it conforms as close as possible to the American Standard. According to DoD OIG and USACE TAN engineers, an experienced electrician should know the difference between the two standards before performing maintenance. However, our engineers concluded that personnel who work with or around the electrical equipment at the DFIP were not safeguarded from electrical safety hazards.

Continued failure to correct the electrical code violations increases the risk of loss of service and the potential of the loss of life for anyone attempting repairs.

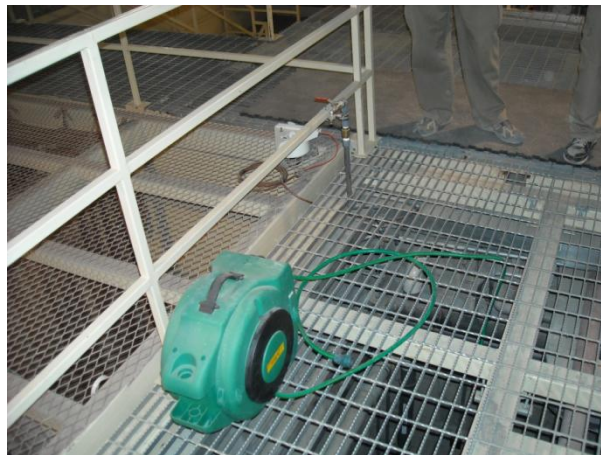
Figure 8. Interim Fix to Fire Suppression System

Figure 8 shows a garden hose located above the detainee cells.

However, the garden hose was not attached to a water source and would be useless in the event of a fire. The lack of a fire suppression system not only puts the detainees at risk, but also the soldiers who guard them.

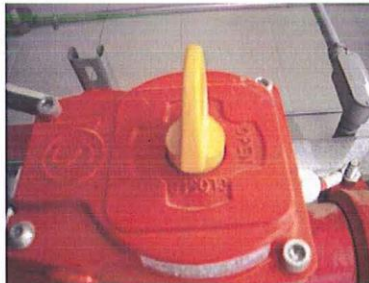
Figure 1. Fire suppression valve turned off in Medical Holding Unit at DFIP

USACE AED-N personnel provided documentation showing that on March 14, 2010, the fire suppression system was disabled. On March 14, 2010, PPI in an email to JTF-435th personnel outlined their process to identify and correct the issues with the sprinkler lines. However, during a walk through of the DFIP on July 19, 2010, we determined that the fire suppression system was still disabled in all buildings on the compound. For example, Figure 1 shows the fire suppression valve in the Medical Holding Unit turned to the closed position.

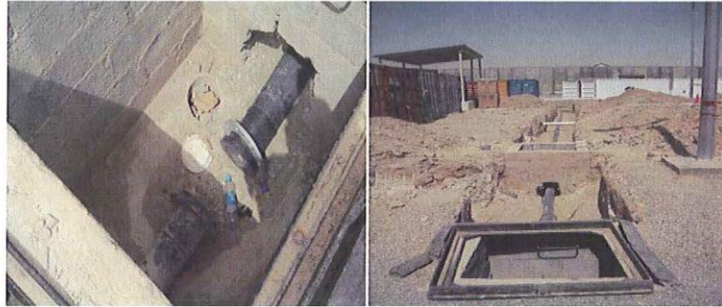
Figure 2. Main fire suppression lines being repaired.

During the same walk through, we also observed that the main water lines for the fire suppression system leading from the pump house had been shut off and dug up for repair by PPI as shown in Figure 2.

On June 20, 2010, USACE AED-N provided a letter to PPI requesting that the fire suppression system be repaired in accordance with the construction warranty. USACE AED-N also requested that PPI submit a detailed repair plan by June 25, 2010. On June 30, 2010, the contractor provided a response with plans to fix the fire suppression system. However, as of October 25, 2010, the fire suppression system was still inoperable.

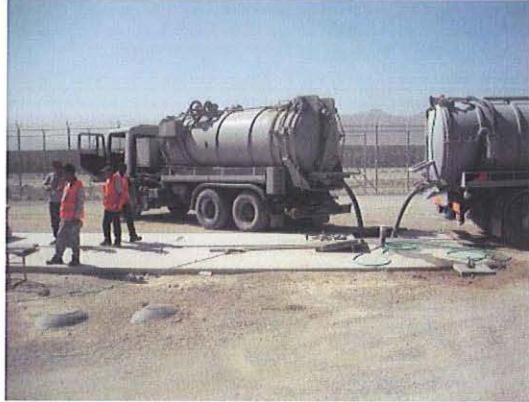
Figure 4. Contractor trucks removing sewage from DFIP lift stations.

To prevent the two sewage lift stations from overflowing, Fluor must bring four sewage removal trucks (see Figure 4) a day into the compound. Because the DFIP is a secure location, every time the trucks have to enter the facility the risk of a security incident increases.

To maintain the health and security of the individuals working and housed at the DFIP, USACE AED-N should require the contractor to immediately repair the lift stations in accordance with the warranty provisions in the contract and ensure the lift stations meet the requirements set forth in the contract.
